Manhole Inspection Summary

Manhole # S35U__053MH

Insp Date: **2/12/09 1:36 PM**

Location Address: **1600 RANDALL-HEATH-ALLEY** Cross Street: **PATAPSCO ST**

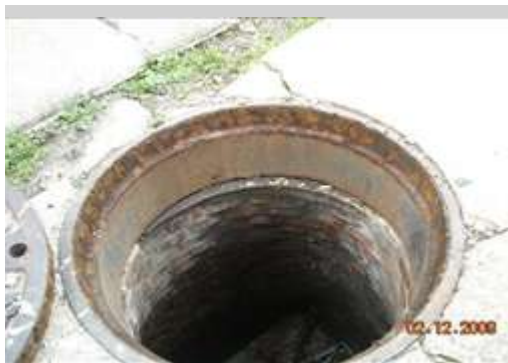
MISC.

Manhole Type: **Terminal** Location: **Alley** Ground Conditions: **Dry**
☐ Prev. Rehab Weather: **Dry** Subject To Ponding: **Sheeting**

INFLOW EVIDENCE FROM SHEETING

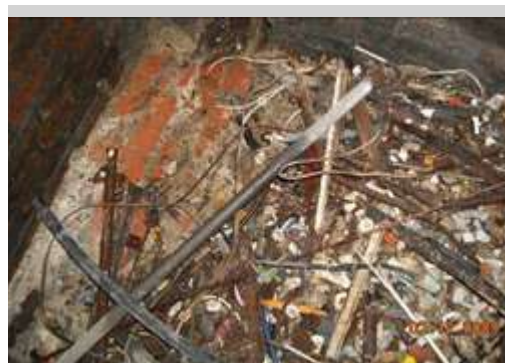
Defect 2

Channel Material: **Brick** ☐ Parged
Channel Exposure: **Fully Open** Junc Dist: **0** nearest .5 ft. Azimuth: **0**
Condition: ☐ Sound ☐ Cracked ☐ Root Intrusion ☐ Deteriorated ☐ Leaks ☒ **Debris**

DEBRIS IN TERMINAL CHANNEL

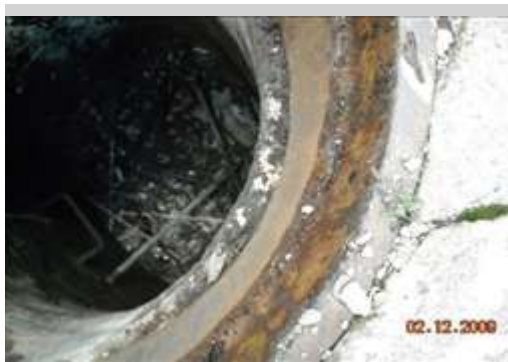
Defect 1

Frame Offset: **1** (in.) Condition: ☒ Sound ☐ Cracked ☐ Leaks

FRAME OFFSET

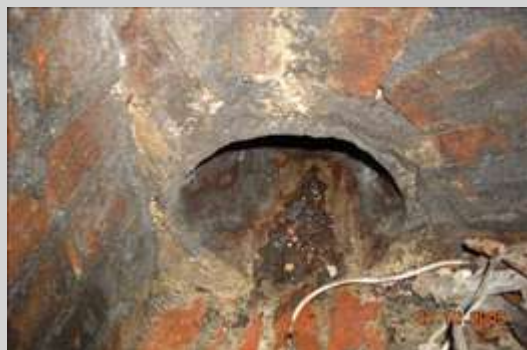
12 O'Clock Outflow

8 in. Circular Gravity Sewer
Pipe Out @ 12 O'Clock

Infiltration: **None** Pipe Seal Cond: **Sound**
